## PRC'S CONTRACTORS' ENVIRONMENTAL

# SHORTCOMINGS

## **ON GEORGIAN HIGHWAYS**

August, 2024 Civic IDEA Authors:

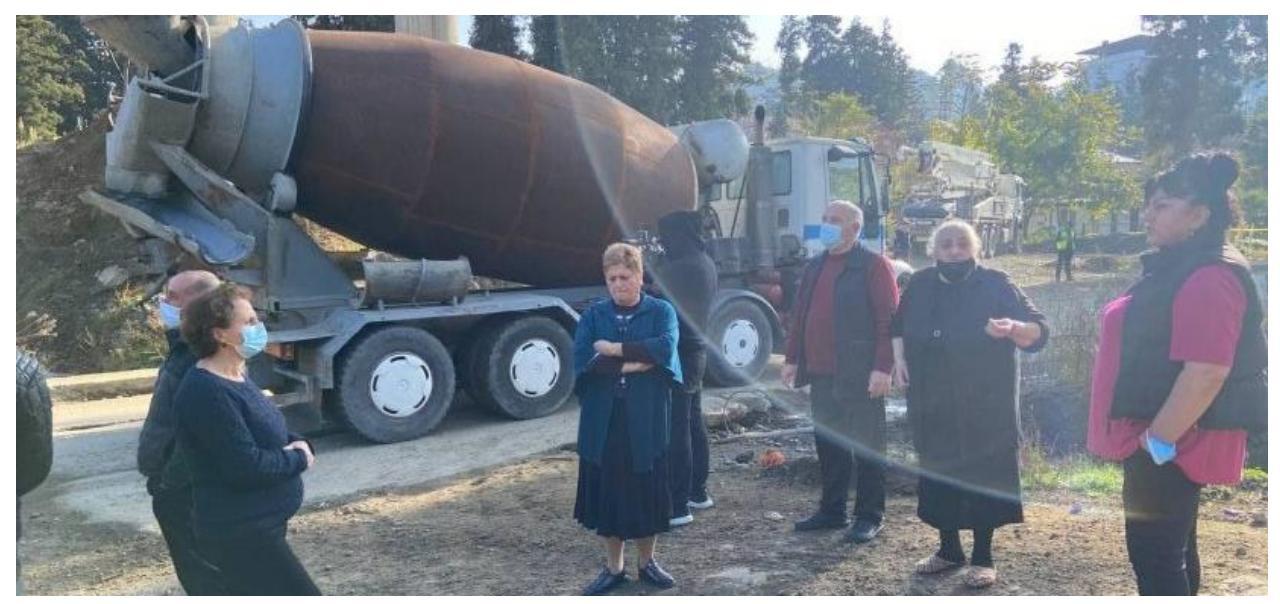
<u>Protests</u> against the project also took place in Makhinjauri, where residents said that inappropriate bypass road construction had changed the riverbed and caused cracks in residential buildings. Due to this modification, homestead plots flooded whenever it rained.

Protests in Makhinjauri; Photo Source: Mtavari Arkhi

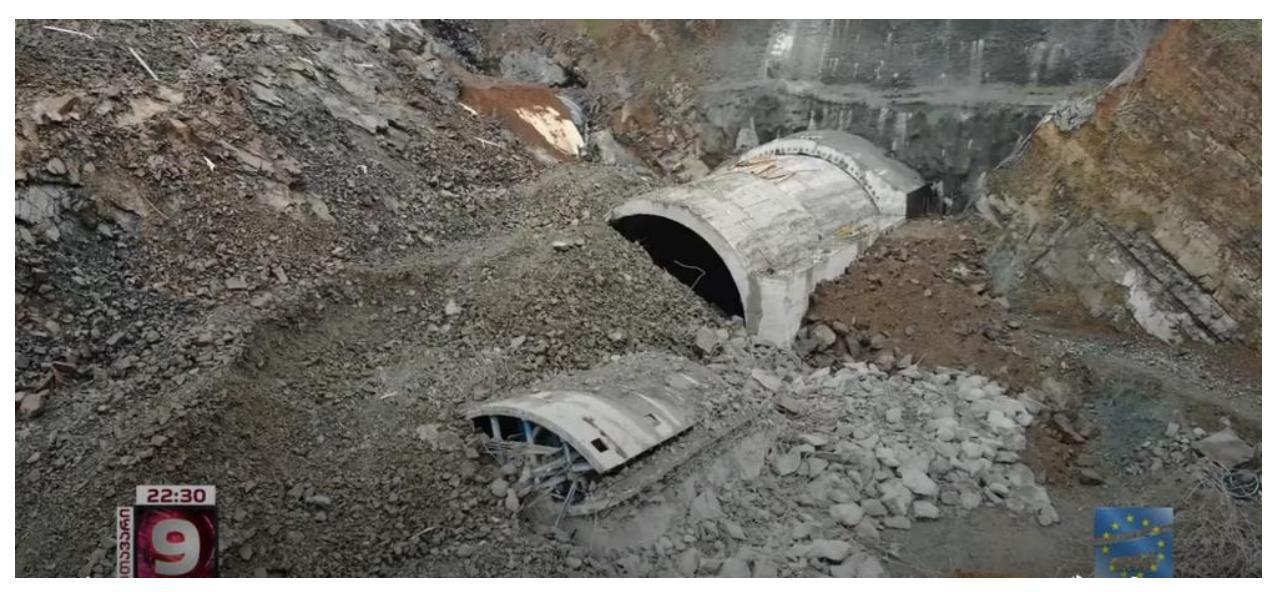
Significant construction-related alterations had occurred by the middle of 2023, most notably an <u>18-meter</u> deviation in a 300-meter tunnel. Additionally, the footage uploaded by locals revealed that sections of the newly constructed highway are submerged in water, presenting major safety risks.

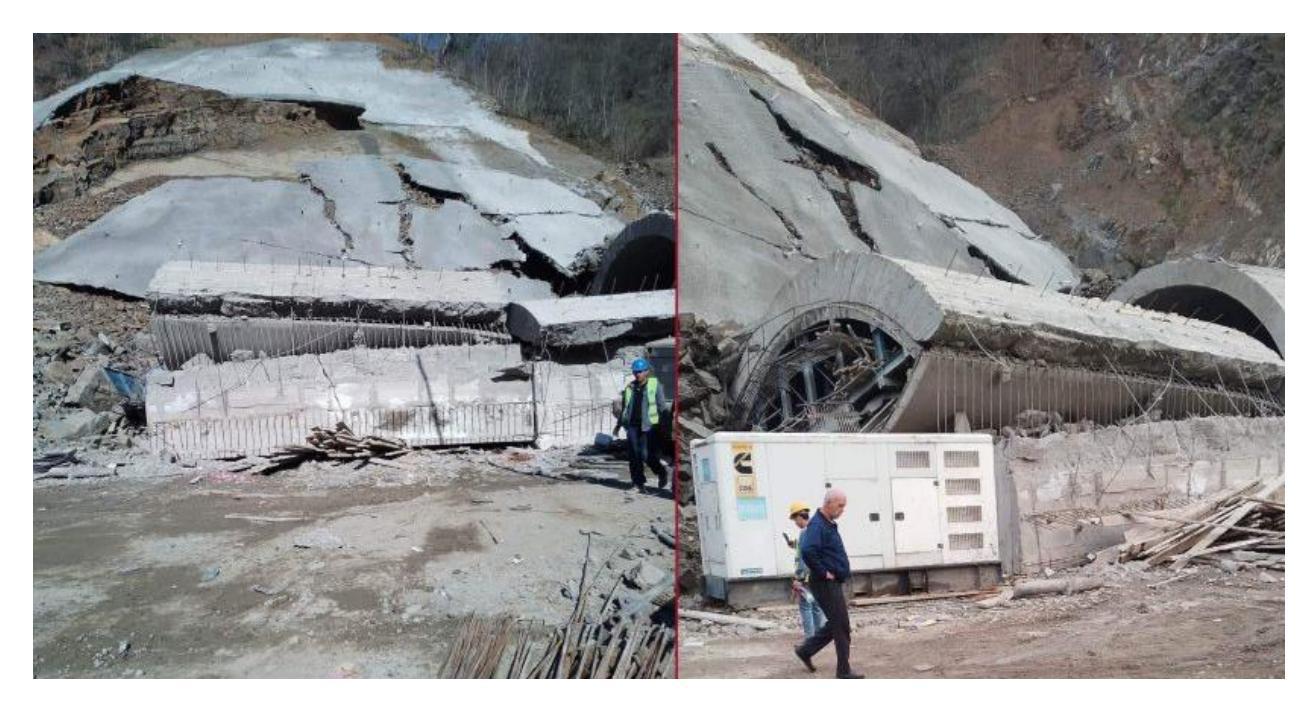
In 2019, before the pandemic, a group of Turkish geotechnical engineers raised alarms about the geological and seismic risks in the area. They reported that the PRC-connected company handling the construction lacked an adequate understanding of the geological complexities. A significant seismic fault in the region was not thoroughly studied, and construction quality control was insufficient. Residents were affected by construction activities, with some reporting damage to their homes due to explosions used during the project. The engineers emphasized that ignorance and inadequate preparation were the primary causes of these problems.
